ABARI Launches *Their own Collision Newsletter*

This News Letter is a pilot effort by ABARI to keep its membership informed and up to date with news and information that is relevant to our day to day operational needs.

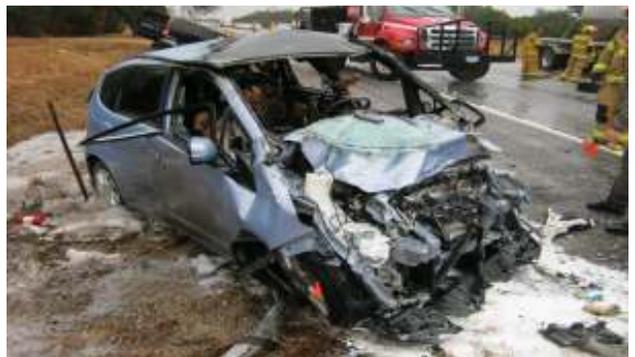
If you have been following the National News you most likely are aware of a certain lawsuit that has made news in Texas. It involves a roof replacement made on a 2010 Honda Fit due to a hail-related claim. The vehicle was repaired and returned to the customer who then subsequently traded the vehicle in. From there it was re-sold to a couple that was unaware of the vehicle's past history. This same vehicle was later involved in a severe head-on accident with another vehicle and this couple sustained serious injuries. It was discovered that the collision shop that performed the roof

replacement from the prior loss failed to follow OEM procedures for the installation of the new roof panel. The new roof panel was installed using only panel bonding without the recommended OEM welding procedures. Upon impact the roof panel separated from the inner structure.

The court found that the improper repair procedures compromised the structural integrity of the vehicle and in the subsequent loss, the collision energy of the impact was not properly channeled away from the occupants as designed by the OEM manufacturer.
